The
San Francisco Earthquake and Fire

A BRIEF HISTORY OF THE DISASTER

A Presentation of Facts and Resulting Phenomena, with Special
Reference to the Efficiency of Building Materials
Lessons of the Disaster

A. L. A. HIMMELWRIGHT, C.E.

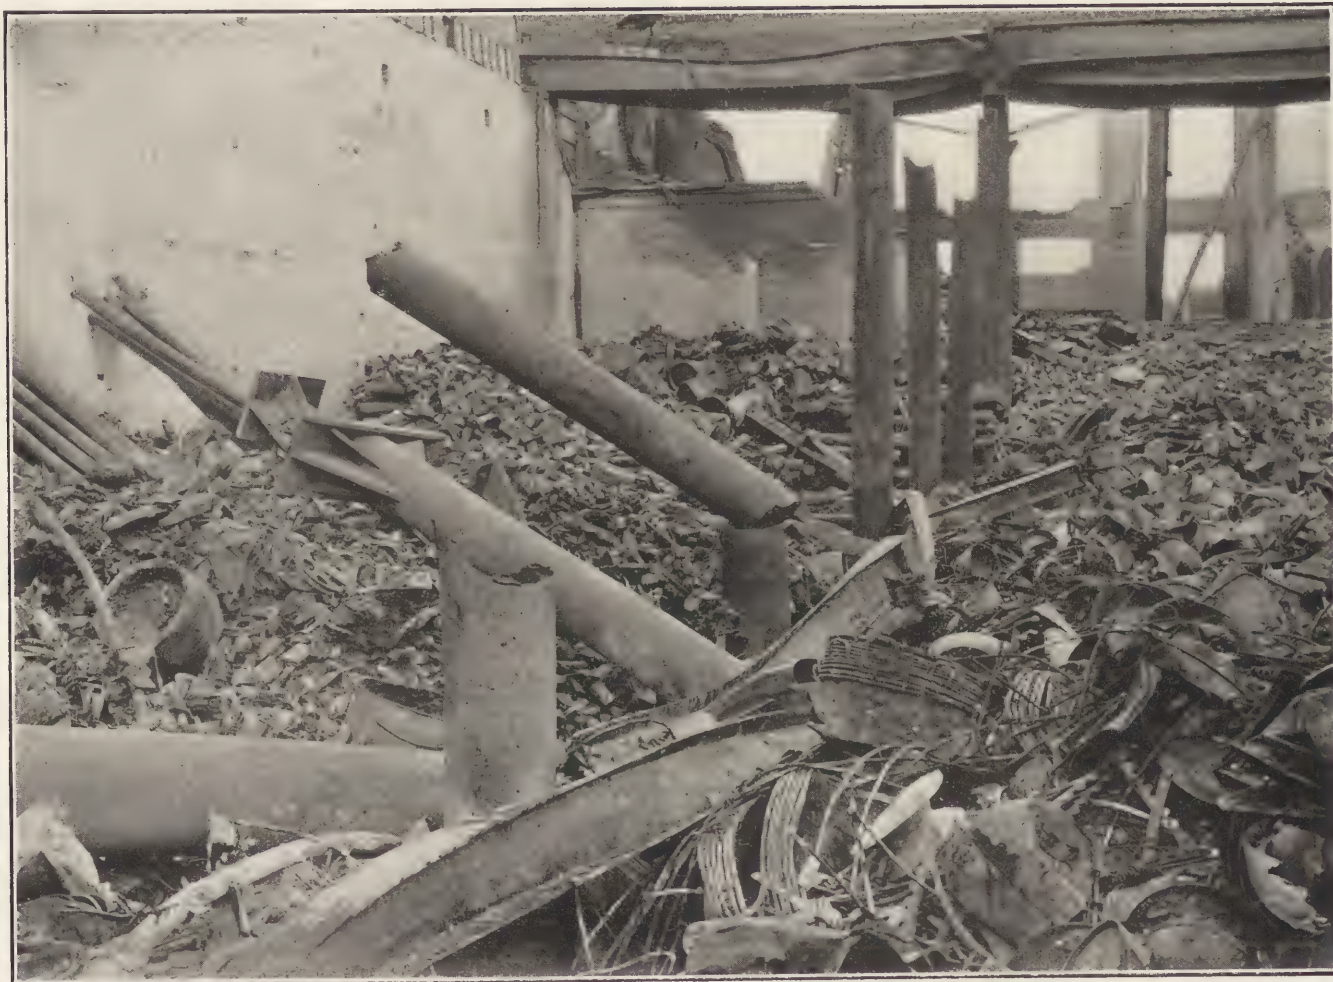
WAREHOUSE. Beale Street, between Howard and Folsom Streets, occupied by The Dunham, Harrigan and Hayden Company. Showing the effect of an intensely hot fire which destroyed cast iron columns. The metal where the columns have been severed is very little thicker than ordinary pasteboard.

The burning of the Class B and other large buildings with wood interiors, generally produced higher temperatures than the contents of the fire-proof buildings. There were numerous instances in the former buildings where cast-iron columns were literally burned in two and where light steel members were similarly severed.

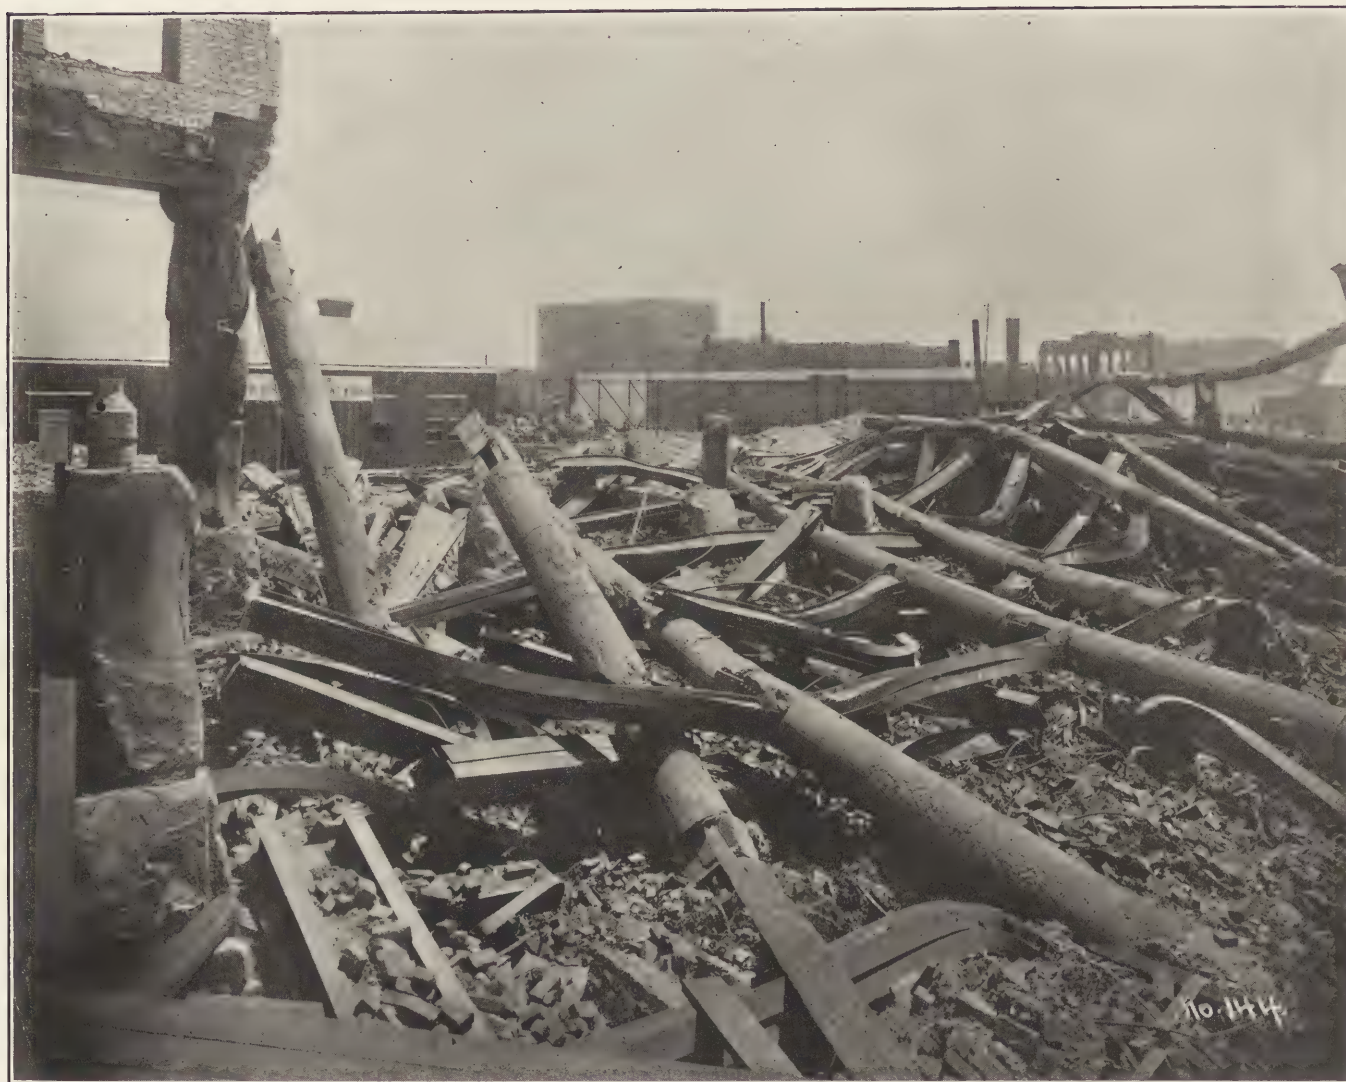
W. P. FULLER BUILDING. Mission and Beale Streets. This was a Class B building. The walls were of brick with wood floors supported by steel framing. The only part of the building fire-proofed was the columns. These were covered with stone concrete, anchored with No. 10 gauge steel wire wrapped spirally around the column at 16" centres. This building was filled with a stock of paints, oils, etc., producing a hot, spectacular fire, and causing the total wreck of the structure. Note the tenacity of the concrete column protection, which remains in place after the severe fire test and the jarring sustained by the columns in falling over. The granite bases are badly spalled, this material being unsuited for carrying loads in locations where it is exposed to fire.

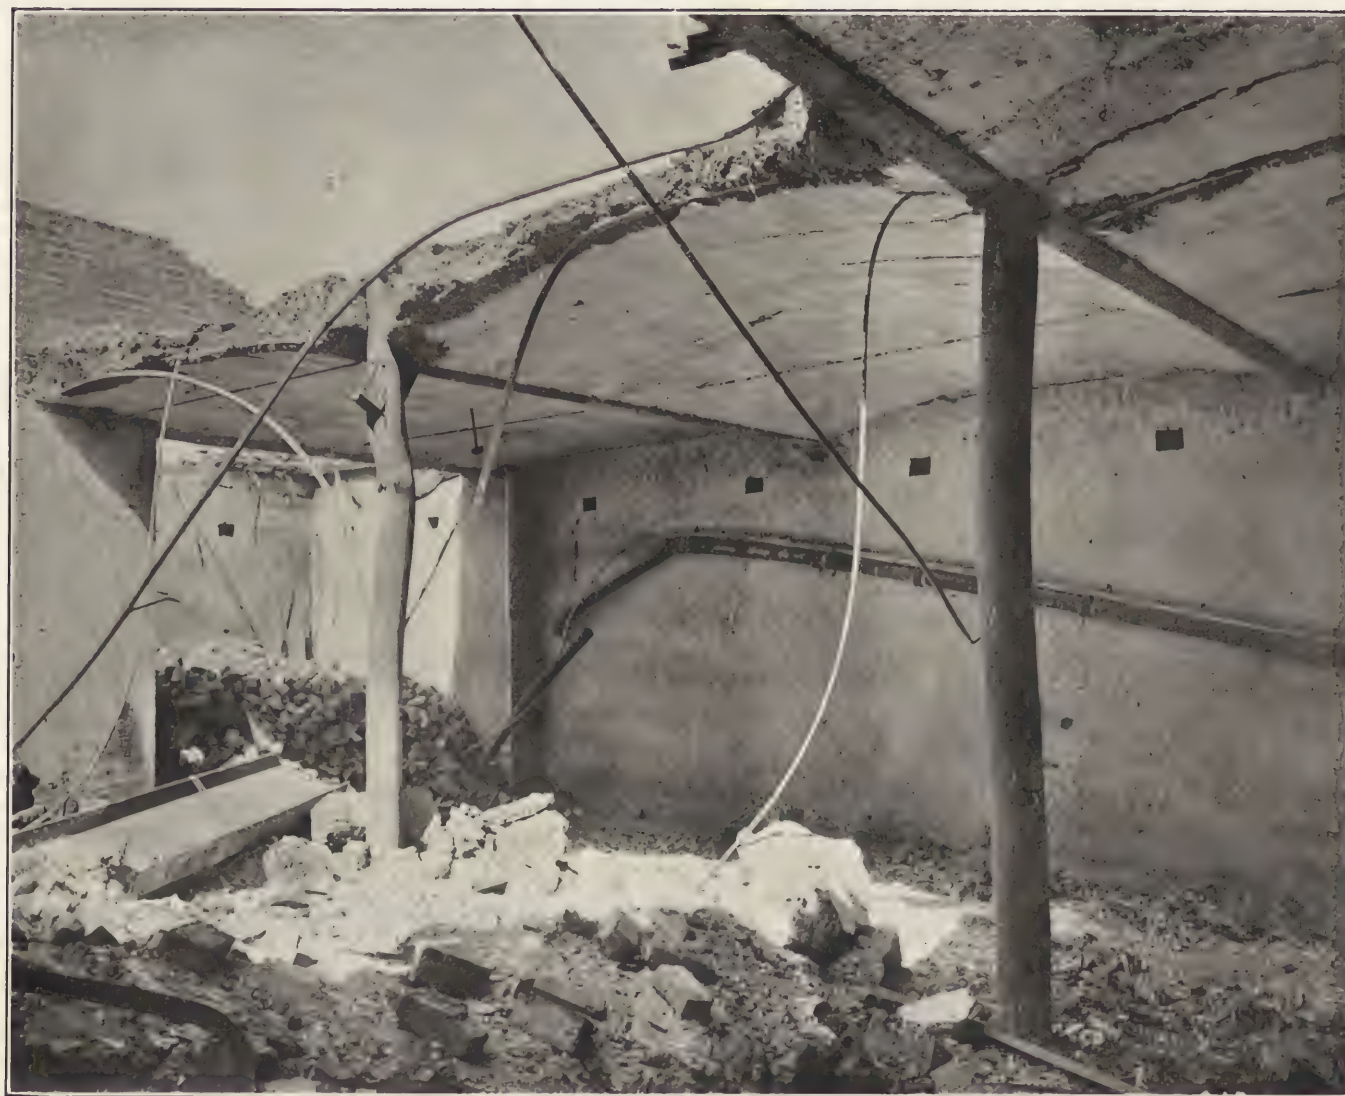
VAULT of the Bancroft-Whitney Publishing Company. In the rear of a building on California Street between Kearny and Dupont Streets. A Standard Underwriters' metal covered door separated this vault from the basement of the building. The fire destroyed the door, igniting the contents of the vault, causing the total and partial failure of the cast-iron columns, and the failure of a section of the concrete arches supported by them. A double fire-proof barrier in the door opening of this vault would probably have saved the contents.
